MPF Builders & Consultants, Inc.

Property Inspection Report 14103

April 11, 2014

Property Address
385 Eagle Trace
Half Moon Bay, CA

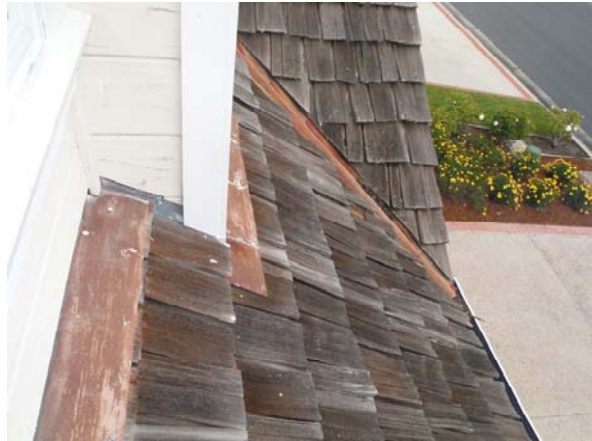
The medium cedar shake roof appears to be in serviceable to poor condition. A medium/heavy cedar shake roof, if properly maintained, should have an expected lifespan of 20 to 25 years. This roof appears to be 20 years old.

There are deteriorated, split, curled and missing shakes. There is underlayment visible.

Roof flashing and penetrations are in a rusted condition.

1. Have a licensed roofer inspect the roof and estimate the cost of replacing the roof as compared to repairing the roof.

1. Repair or replace the roof and flashings as recommended by a licensed roofing contractor.

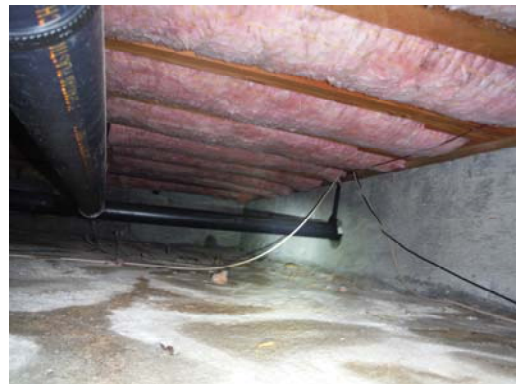
The perimeter foundation of the home is a concrete wall with a footing foundation. The depth or types of the footings is not known, nor a part of this report.

The foundation area was damp at the time of the inspection. There are signs of substantial past water infiltration.

There is efflorescence on the side walls of the foundation and piers. This is caused from water infiltration through the concrete.

This area should be monitored in winter for excessive water infiltration. If that occurs, then additional drainage measures are highly recommended. Consult with a drainage expert concerning the all the drainage alternatives. However, reconstructing the rear deck to be a waterproof deck may alleviate much water in the sub area.

1. Read the Structural Pest Control Inspection Report for further recommendations.
2. Monitor the drainage. See Exterior section.
3. Clean the cellulose debris from the sub area.

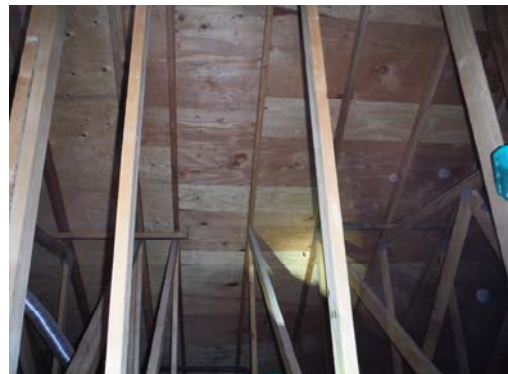
The attic is in satisfactory condition. The roof framing is 2"X 4" trusses, 24"on center. The attic is insulated with 6" of fiberglass insulation. Attic ventilation is adequate.
