Comprehensive Realty Inspections dba Global Property Inspections

Greg Flowers, 947 Malaga St, Half Moon Bay, CA, 94019

Inspection Date :
10/9/2013

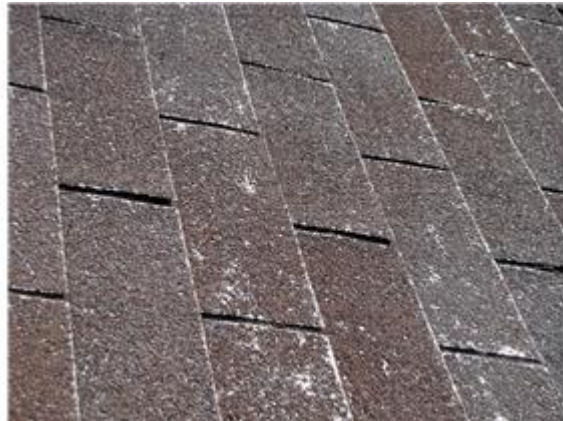
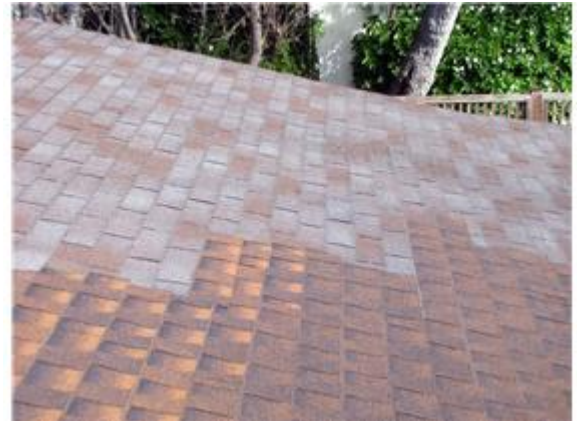
Comments : **Leaks not always detectable.**

Excessive granular loss noted on older roofing. Partial roofing replacement noted in several large areas.

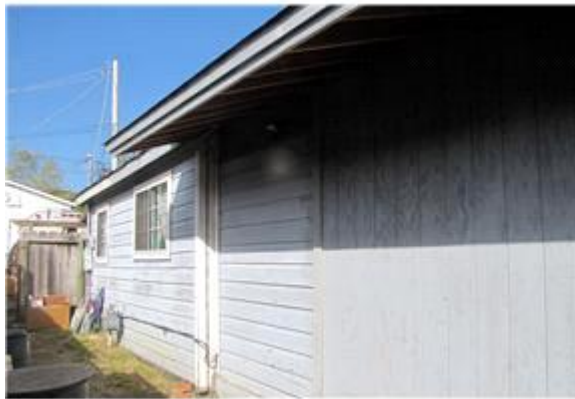
Comments : No drainage system present for roof. Recommend consulting a licensed roofing contractor for remedies.

No drainage system present for roof. Recommend consulting a licensed roofing contractor for remedies.

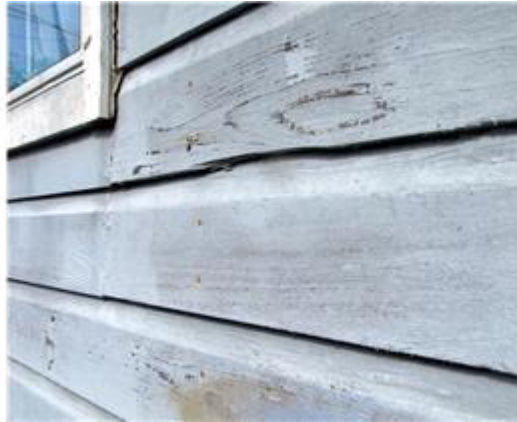
Comments : Exterior wood siding and trim needs caulk and painting. Inadequate clearance between siding and soil at front and sides. Dry rot noted on lower boards.

Exterior wood siding and trim needs caulk and painting. Inadequate clearance between siding and soil at front and sides. Dry rot noted on lower boards.

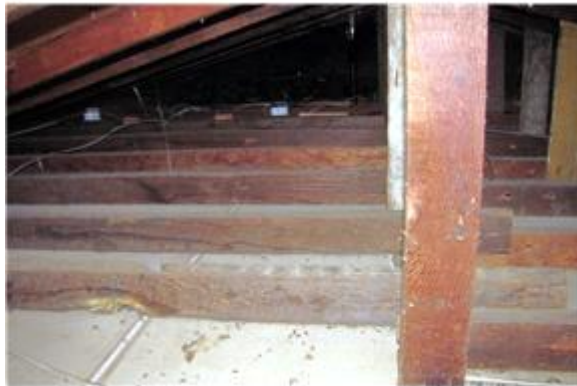
Comments : No insulation present. Recommend installing the appropriate type and amount of insulation to meet today's standards for proper R values.

No insulation present. Recommend installing the appropriate type and amount of insulation to meet today's standards for proper R values.

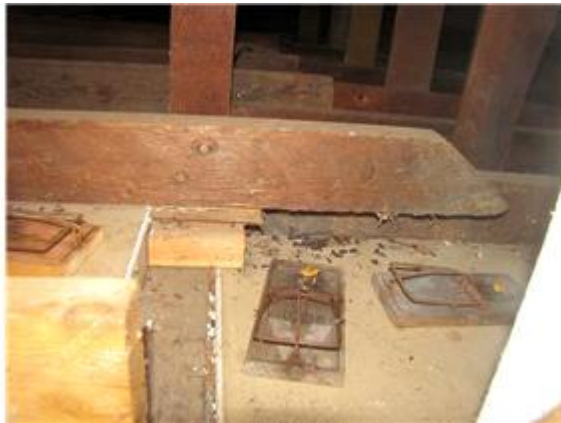
Comments : Limited visibility due to obstructions. See Electrical Section for additional Information.

Rodent droppings noted in attic space.

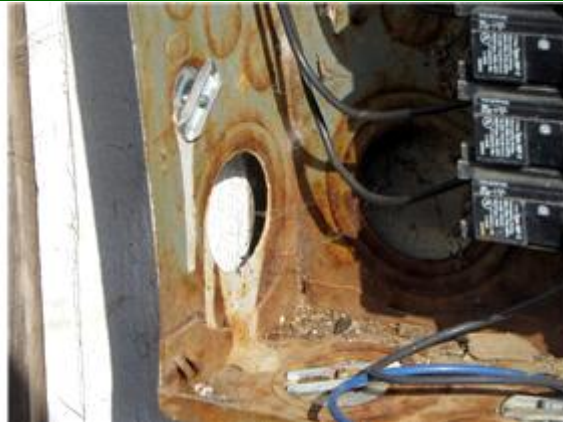
Open knock-outs present in side of panel. No main disconnect present. Recommend adding a main disconnect for safety. Several smoke detectors missing or not functional. Recommend replacing and adding smoke detectors as needed. Rust starting to form at base of panel.

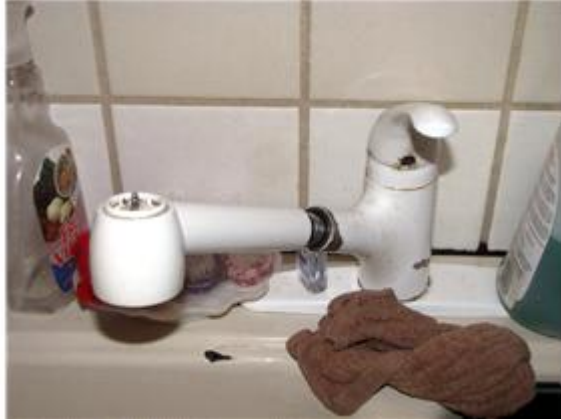
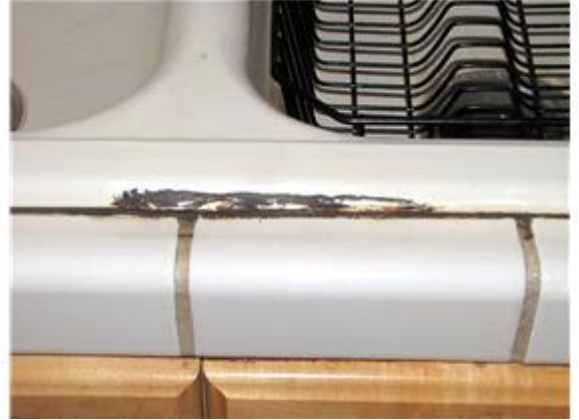
Comments : * Note: Non-ducted exhaust fan. Dishwasher is being replaced per owner.

GFCI outlet to the right of the sink not functioning properly (will not trip with an outside source). Recommend replacement. Faucet missing parts. Recommend replacement. Front of sink starting to rust. Front burners on range do not light.

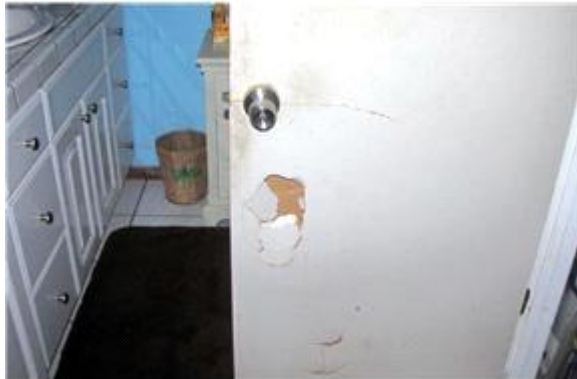
Comments : Door is damaged. Right sink stopper is missing. Left sink stopper not functioning properly. Repairs recommended.

Door is damaged. Right sink stopper is missing. Left sink stopper not functioning properly. Repairs recommended.
