WOOD DESTROYING PESTS AND ORGANISMS INSPECTION REPORT

BUILDING NO. 5806	STREET, CITY, STATE, ZIP COLDWATER DR, CASTRO VALLEY CA 94552	Date of Inspection 1/11/2010	No. of Pages 6
-----------------------------	---	--	--------------------------

OMEGA TERMITE CONTROL, Inc.

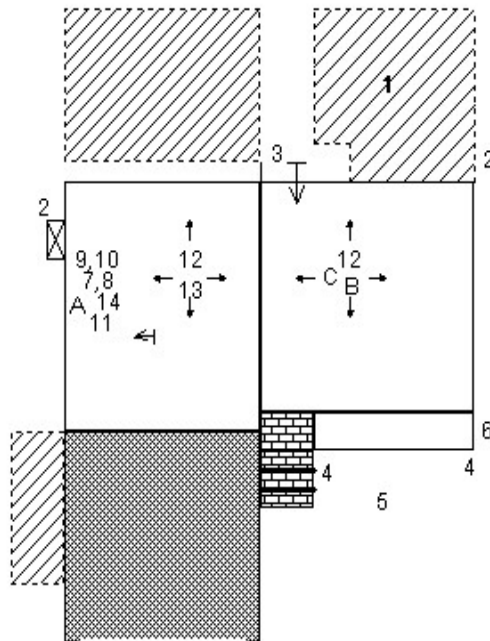
DIAGRAM IS NOT TO SCALE. FINDINGS ARE IN APPROXIMATE LOCATIONS.

ITEM 2 FINDING The roof framing is fungus damaged at the area(s) indicated on the diagram.

ITEM 3 FINDING There are holes in the exterior stucco at the area(s) indicated on the diagram.

RECOMMENDATION Remove the damaged wood members and replace with new material as necessary. Our job quotation for this item does not include patching the disturbed areas of the roof covering. A LICENSED ROOFING CONTRACTOR SHOULD BE CONTACTED TO FACILITATE ANY NEEDED REPAIR TO THE ROOF COVERING. Omega will paint to match as closely as possible. NOTE: We will install felt paper over any area where the roof sheathing is repaired. This will be done as a courtesy only. We do not guarantee these areas against leakage.

RECOMMENDATION Patch the holes to eliminate the excessive moisture condition. No painting is included in this job quotation.
